Roanoke, Town of (Roanoke Methodist Protestant Church) Roanoke Lewis County West Virginia HABS No. WV-209-A

WRITTEN HISTORICAL AND DESCRIPTIVE DATA

# ROANOKE, TOWN OF THE ROANOKE METHODIST PROTESTANT CHURCH

HABS No. WV-209-A

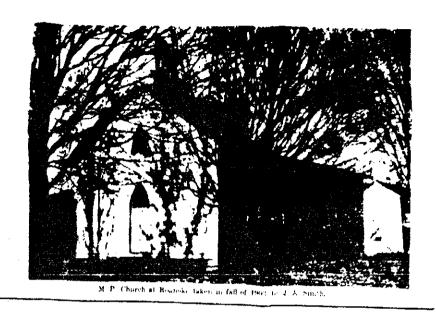
The Roanoke Methodist Protestant Church, ca. 1903, southeast and northeast vations. Photograph appeared in the 17 March 1954 issue of the Weston Independent (Alta Anderson Photograph Collection).

The church was constructed by the parishioners (Blaine Rollyson, Jr. 1981, pers. comm.) using poplar (Liriodendron sp.) timbers and siding. The original building is said to have been rough-hewn and plain in appearance with heavy wooden floors and handmade pews (painted off-white) that were near and surrounded two pot-bellied stoves; the seats closest to the stoves are said to have been reserved for the use of the church trustees (Gordon and Nell Hall 1981, pers. comm.). A dais extended across the width of the front of the church; a chair on one side and a screen on the other separated an area reserved for Sunday school classes. In the center of the pulpit area was a lectern and a simple altar, the latter merely a board supported on twin posts. There were no crosses or icons. The floor at the front of the church was carpeted, but the two side aisles were bare, rough and unpainted. Originally, in the rear of the sanctuary two doors (one serving each of the aisles) opened into a small vestibule where parishioners could hang coats, caps and other items of winter clothing The church entrance consisted of a single large but plain door (Bertha Brinkley 1981, pers. comm.).

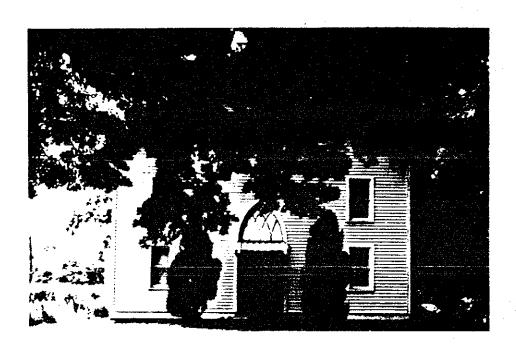
Perspective control photograph of the southeast elevation of the Roanoke Methodist Protestant Church in 1981. Note suspended aluminum awning.

Porch: A 4'6" deep x 6'4 1/2" wide x 7" thick sandstone slab forms a porch at the front (southeast) of the structure; it is covered by a suspended aluminum awning.

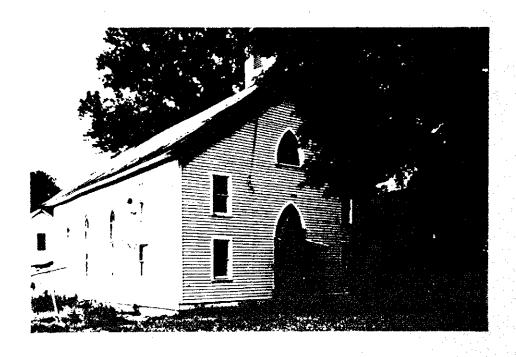
Perspective control photograph of the southeast and southwest elevations of the Roanoke Methodist Protestant Church in 1981.

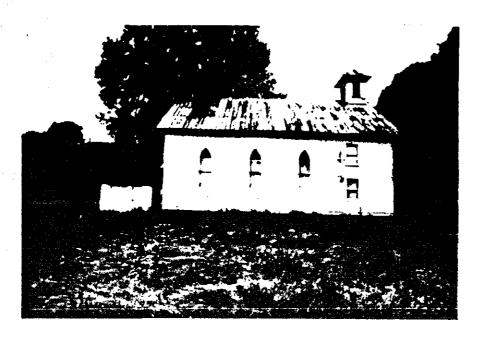
The Roanoke Methodist Protestant Church, southwest elevation in 1981. The modern concrete block structure to the rear of the church contains restrooms. The sheet metal flue pipe in the church furnace can be seen immediately to the left of the acctangular double hung sash windows.

Chimneys: A sheet metal furnace flue pipe projects through the southwest roof slope toward the front of the structure.

Outbuilding: A modern gable-roofed, concrete block construction restroom structure is situated at the west rear corner of the church.

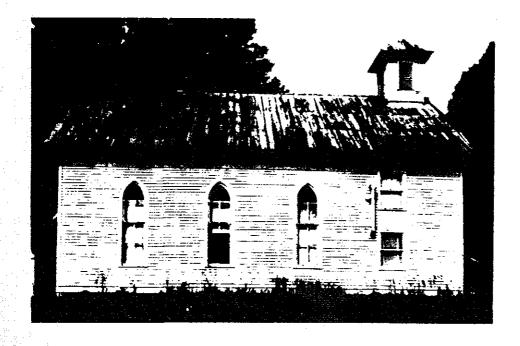
Perspective control photograph of the southwest elevation of the Roanoke Methodist Protestant Church in 1981. Note belfrey and lancet windows.

General Description: The Roanoke Methodist Protestant Church is a two story rectangular frame (clapboard siding) structure with a gable roof; lancet windows are found on the southwest and northeast elevations; the church is surmounted by a belfrey.

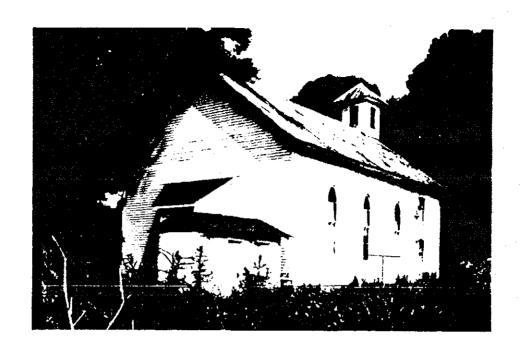
Perspective control photograph of the northwest and southwest elevations of the Roanoke Methodist Protestant Church in 1981. Note the concrete block privy.

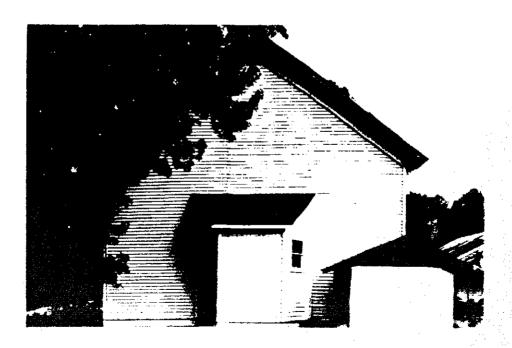
Perspective control photograph of the northwest elevation of the Roanoke Methodist Protestant Church in 1981. The apse constructed along this elevation was built in the 1950s as part of a general remodeling program. Note concrete block privy at right.

Walls: The walls are composed of 4"-4 1/4" clapboards and corner boards, both of which are attached with cut nails and are painted white; a recent addition,

which was built to extend the chancel area, is sided with 5" German cove siding painted white. The lancet windows on the southwest and northeast elevations

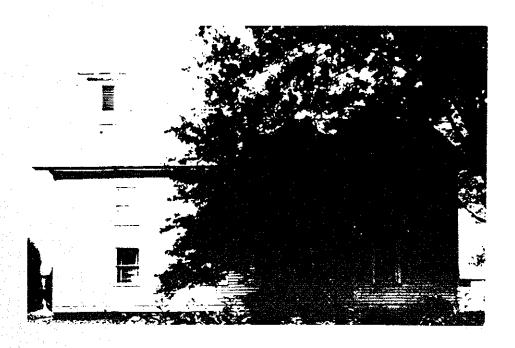
Perspective control photograph of the northeast elevation of the Roanoke Methodist Protestant Church in 1981.

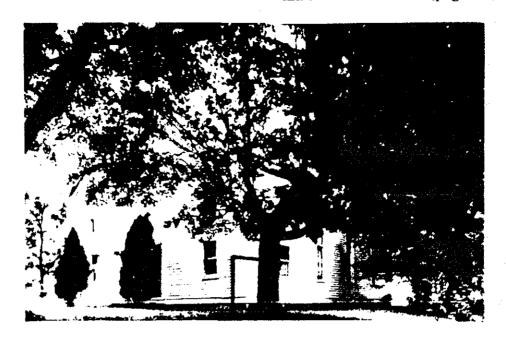
Perspective control photograph of the northeast and southeast elevations of the Roanoke Methodist Protestant Church in 1981.

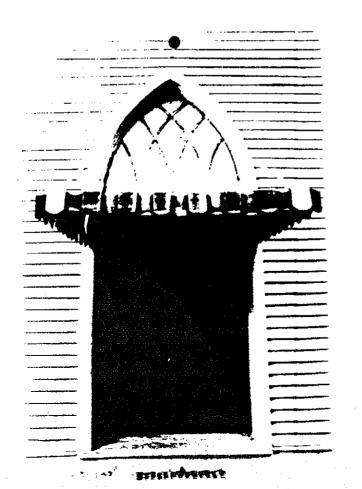
The entrance to the Roanoke Methodist Protestant Church in the southeast elevation in 1981. Note the suspended aluminum awning as well as the arch transom.

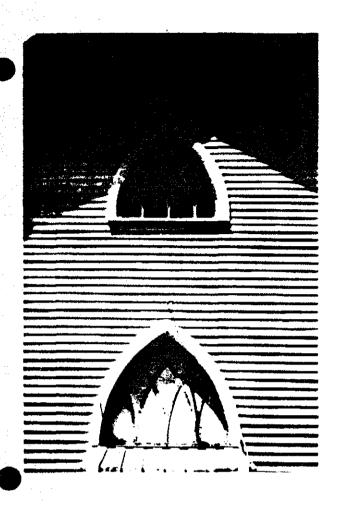
Close-up of the arch transom and arch window in the southeast elevation of the Roanoke Methodist Protestant Church in 1981.

Note the suspended aluminum awning over the entrance to the narthex.

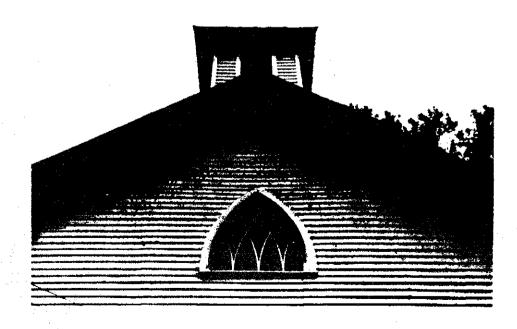
The arch window and belfrey in the southeast elevation of the Roanoke Methodist Protestant Church in 1981.

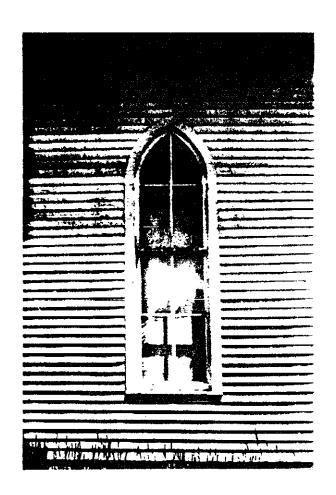
Close-up of lancet window in the southwest elevation of the Roanoke Methodist Protestant Church in 1981.

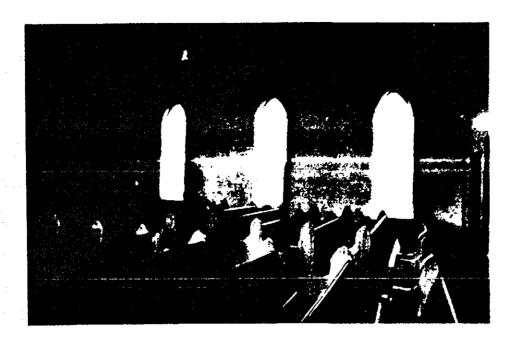
The nave of the Roanoke Methodist Protestant Church in 1981. The interior the church was remodeled extensively in the 1950s. Note the lancet windows in the method the lighting fixtures in the ceiling.

Function: nave and chancel.

Dimensions: 31'1" x 42'1"; 16'1" ceiling.

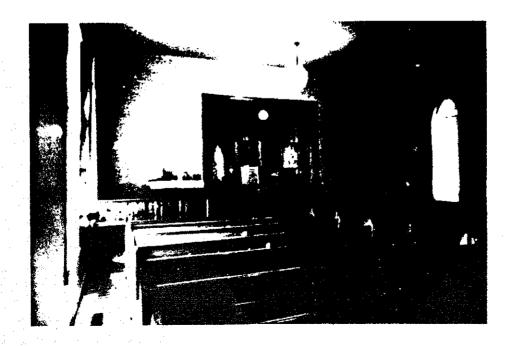
The nave and chancel area of the Roanoke Methodist Protestant Church in

Other: The chancel is a 10'11" x 31'1" area raised 2' above the floor; it is eached by ascending either of two sets of carpet-covered steps located to the right and eft of the pulpit which is at the front center of the chancel; steps have a 33" width x 11" read x 8 1/2" rise and 7 1/4" riser; the chancel is carpeted.

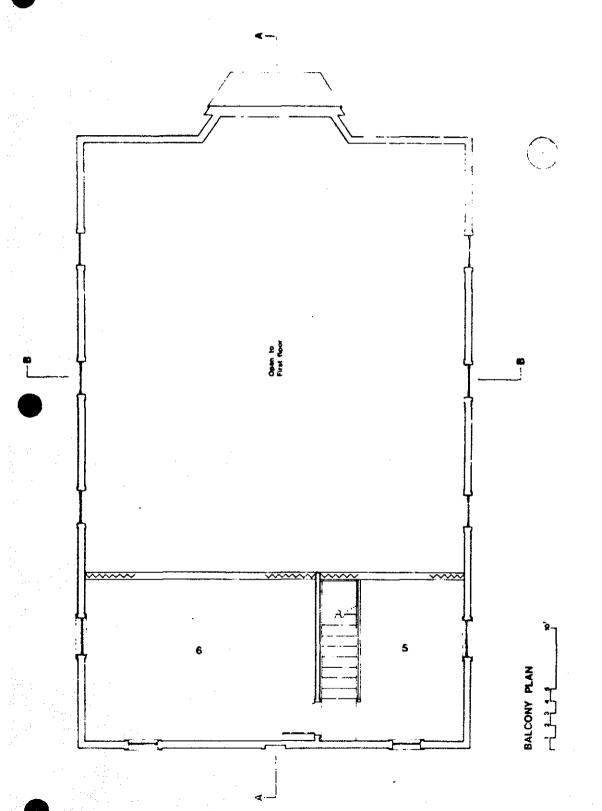
Second floor plan of the Roanoke Methodist Protesant Church.

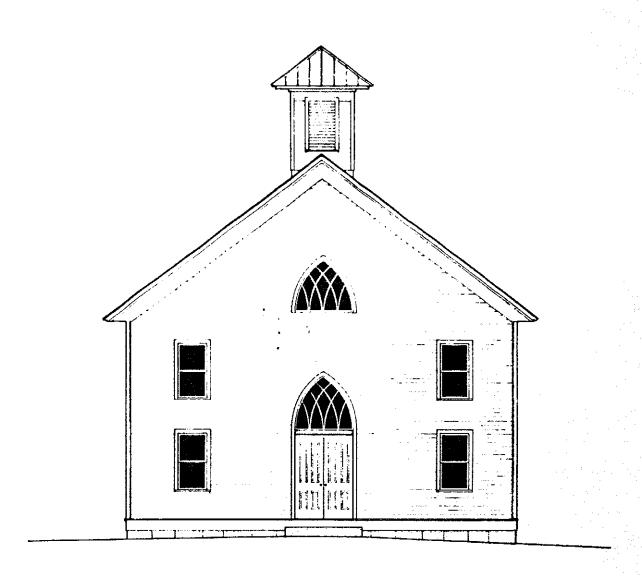
SOUTHEAST ELEVATION

Southeast elevation of the Roanoke Methodist Protestant Church.

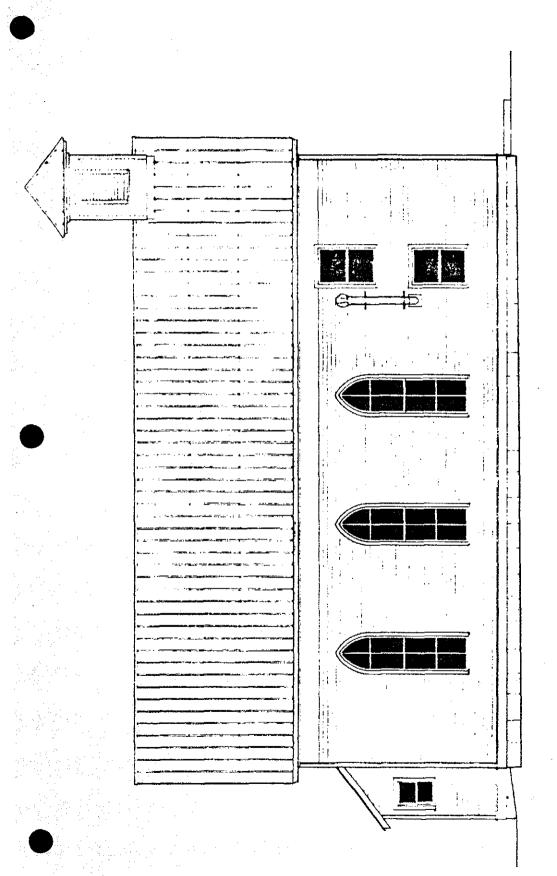
SOUTHWEST ELEVATION

Southwest elevation of the Roanoke Methodist Protestant Church.

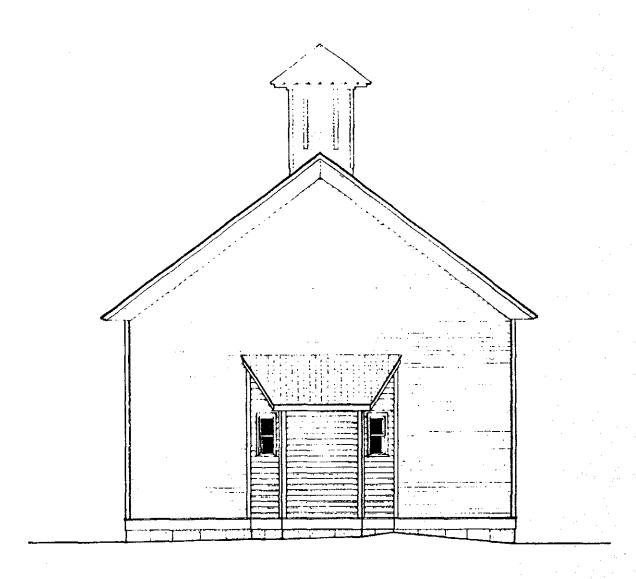
NORTHWEST ELEVATION

Northwest elevation of the Roanoke Methodist Protestant Church.

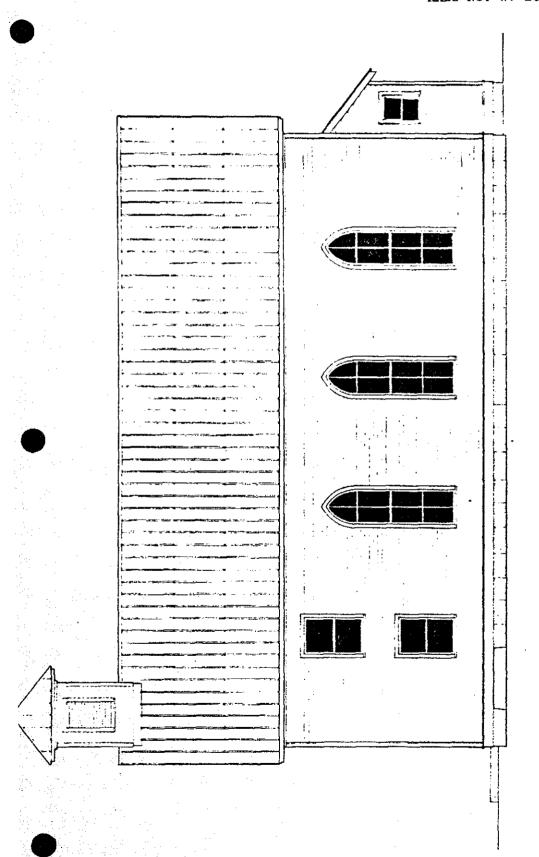
NORTHEAST ELEVATION

Northeast elevation of the Roanoke Methodist Protestant Church.

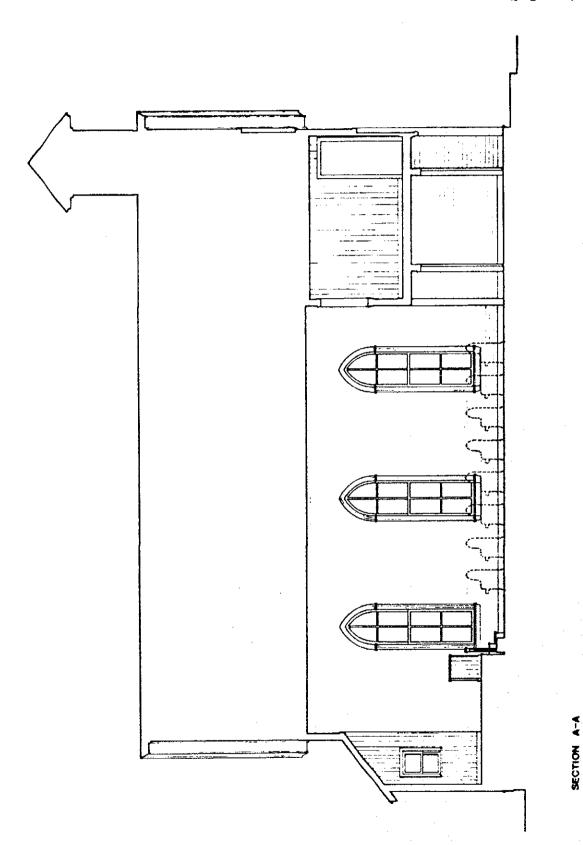
Longitudinal section (A-A) through the Roanoke Methodist Protestant Church.

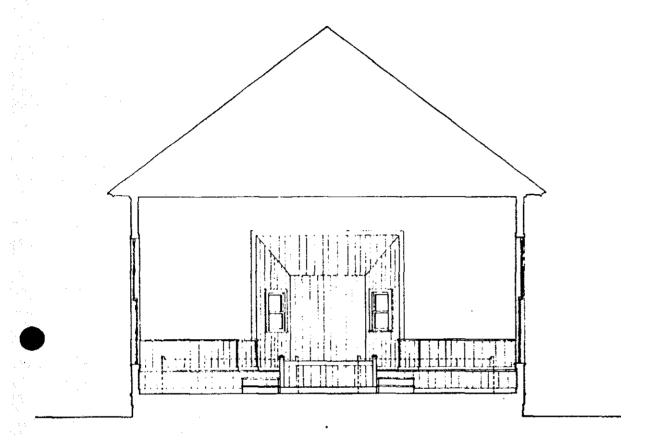
SECTION B-B

Transverse section (B-B) through the Roanoke Methodist Protestant Church.

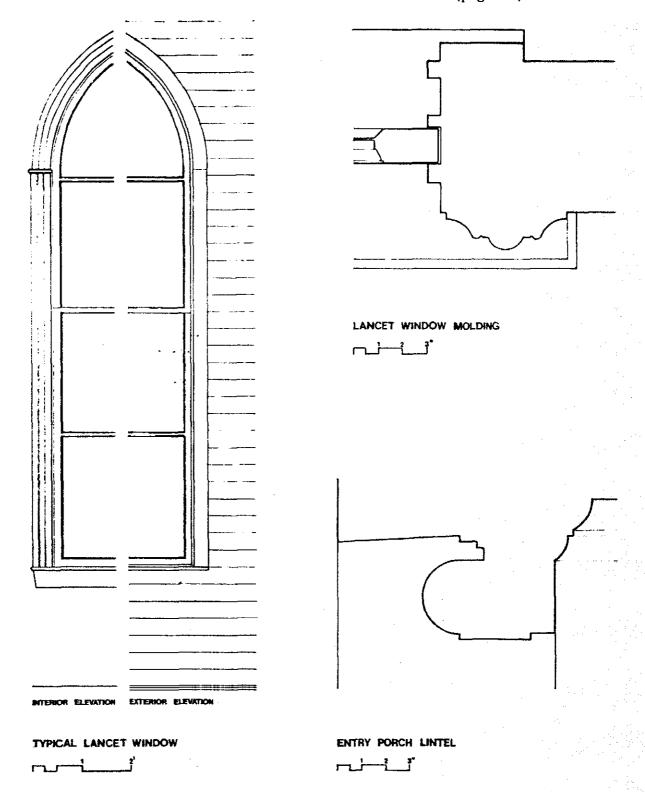
Typical architectural details in the Roanoke Methodist Protestant Church.
